Independent Environmental Audit (IEA) Western Coal Services

for Springvale Coal Pty Ltd

Springvale Coal Services, Castlereagh Highway, Blackmans Flat NSW 2790

April 2016

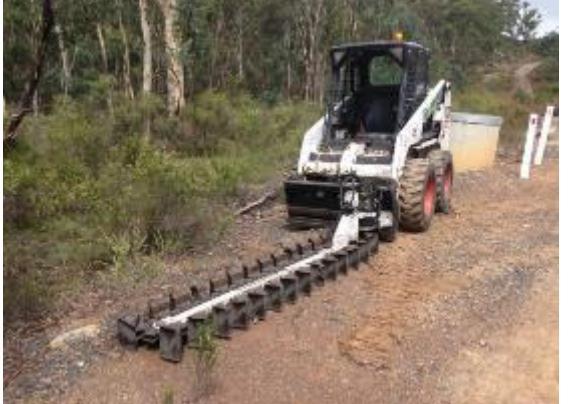
4-25.

Photo #	Comment	Photo
4-25	A Bobcat® with a customised attachment

A Bobcat® with a customised attachment that is used to clear coal from beneath the overland conveyors.

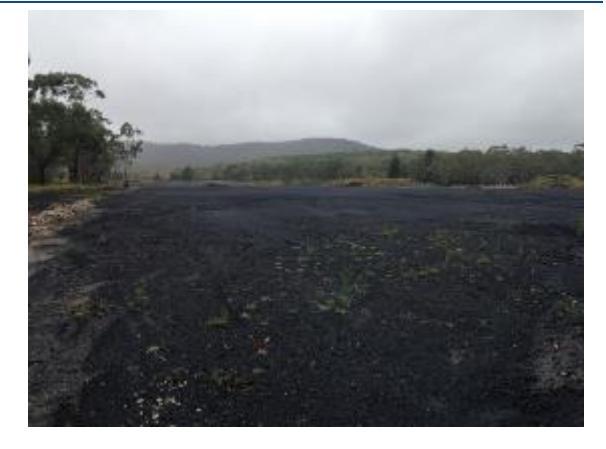
4-26. Kerosene Vale Stockpile Pad

No ROM coal was stockpiled on the pad (approximately 3.5 hectares) at the time of the site inspection and WCS management reported that none had been stored on the site during the audit period. There was evidence of minor gullying from the centre of the pad towards the edges and sediment controls in the form of rock dams, and gabions were evident in the drainage channel to the north of the pad. The drainage channel reports via a flocking station to LDP-003.

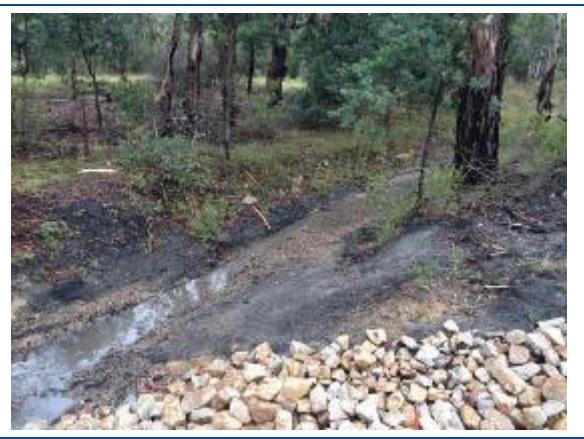
4-27. Kerosene Vale – Drainage Channel

Sediment controls in the form of rock dams, and gabions were evident in the drainage channel to the north of the stockpile pad. The drainage channel reports via a flocculation station to LDP-003.

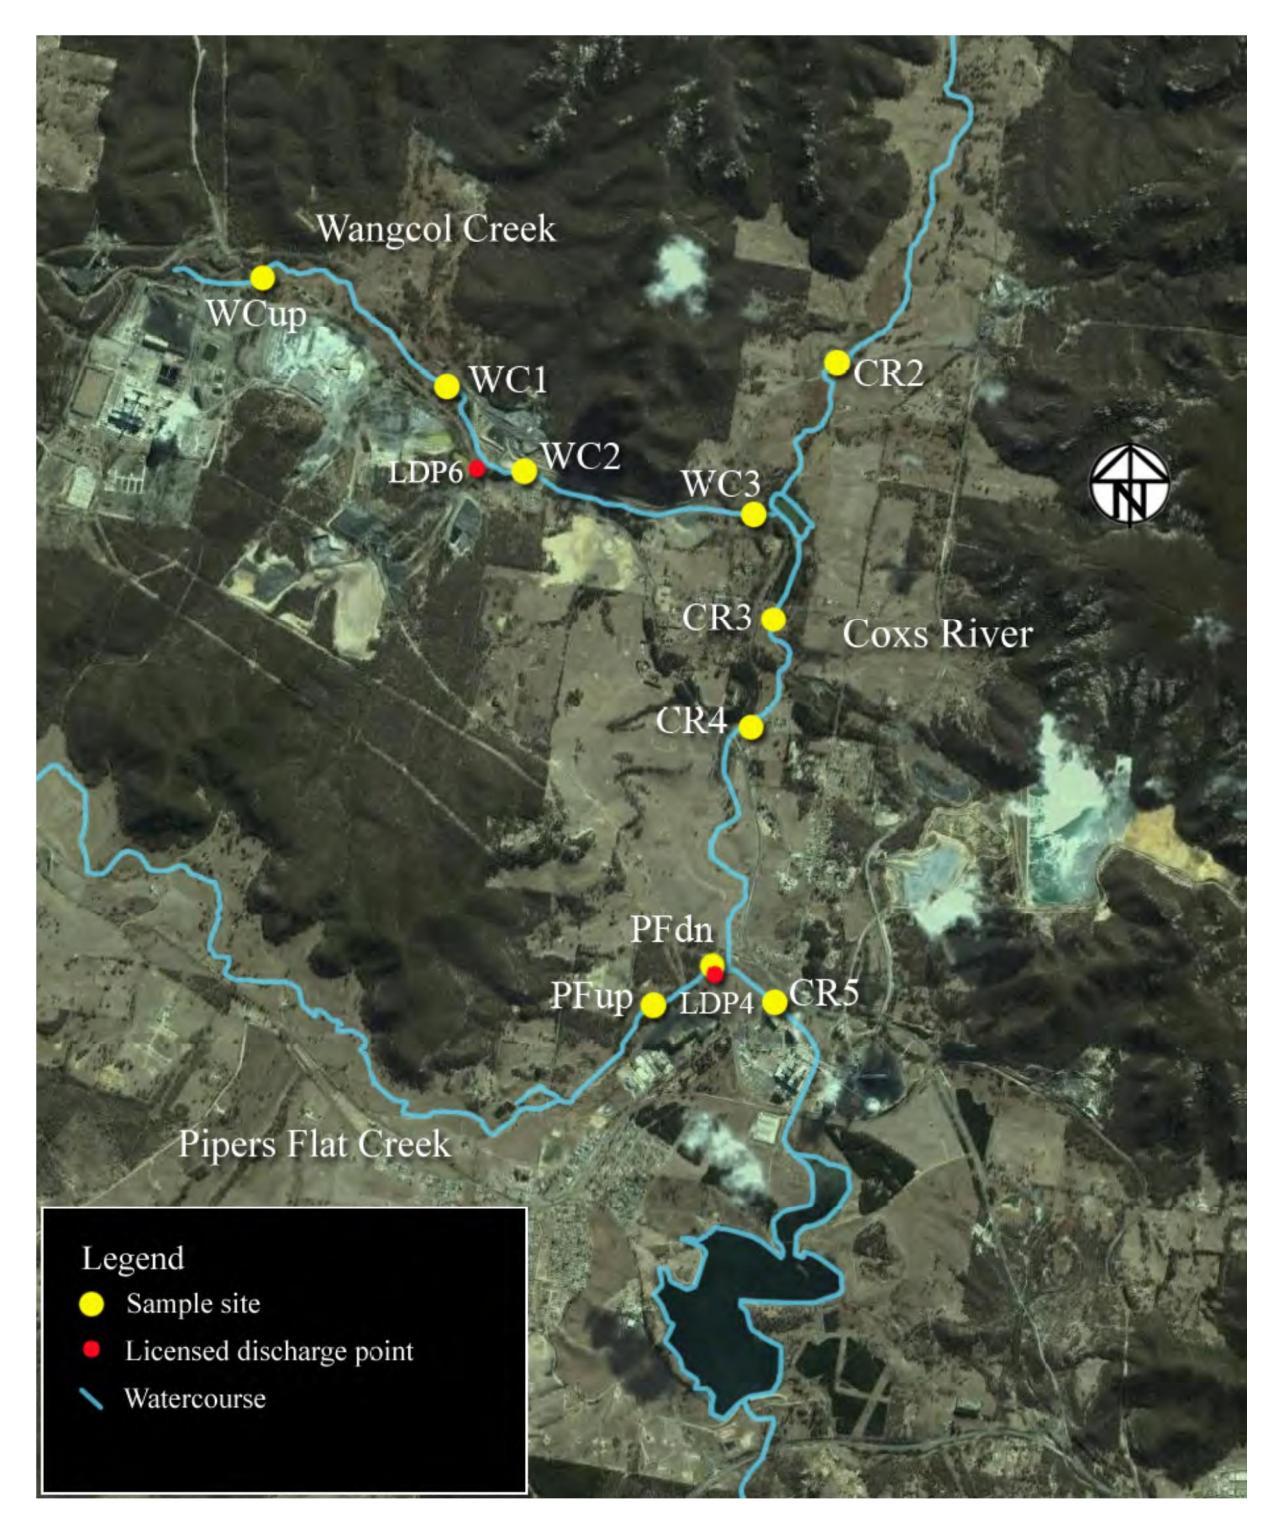
Figure 7-1 - Centennial West Aquatic Ecology Sampling Sites Spring 2015

- All Wangcol Creek sites with the exception of downstream monitoring site WC3 recorded pH values within the ANZECC (2000) default trigger range for slightly disturbed upland rivers of 6.5 to 8.0 pH units.
- Mean conductivity levels in Wangcol Creek ranged from 442us/cm Upstream (WCup) to 1513 us/cm at WC2.
- Maximum conductivity levels for WCup and WC2 were 528 and 2657 us/cm respectively.
- The individual site macroinvertebrate taxa diversity ranged between 14 taxa at WC2 and 25 taxa at CR2, with a survey mean (± SD) of 20.2 ± 3.0 taxa per site recorded over all ten of the Western Coal Services licensed discharge monitoring sites.

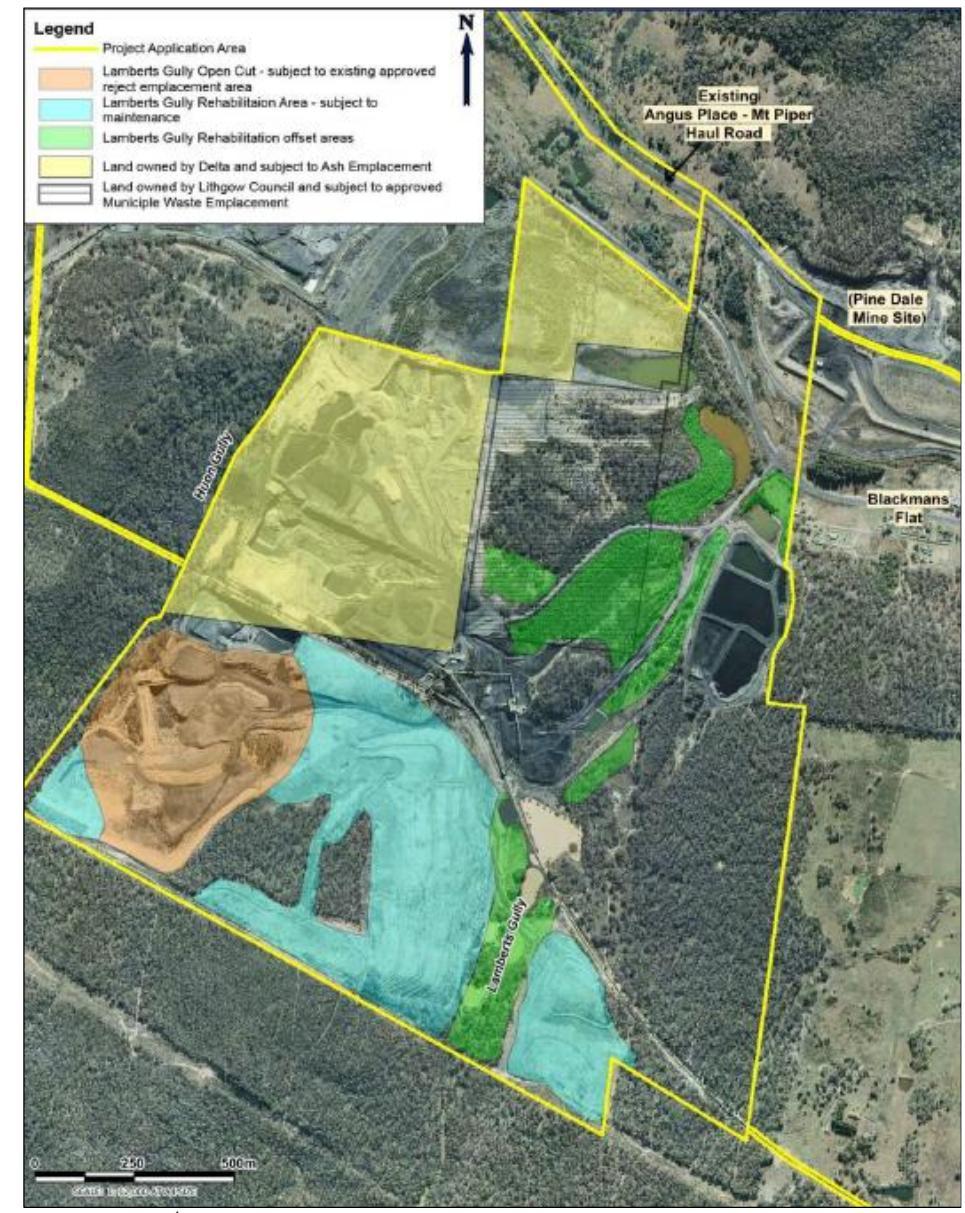
Figure 9-1 – Overview of WCS Rehabilitation Areas

Figure 9-1 presents an overview of the rehabilitation areas at WCS. Figure 9-2 presents the proposed rehabilitation program at year five. Figure 9-3 presents the rehabilitation areas at Kerosene Vale. Photographs concerning rehabilitation from the site inspection are presented in Table 9-1 and Table 9-2.

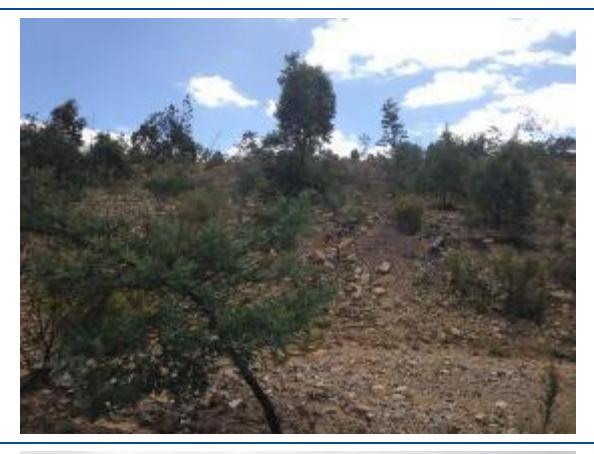
6-9. Rehabilitation Area – subject to maintenance

Understory development varied across the rehabilitated areas with some areas having less understorey.

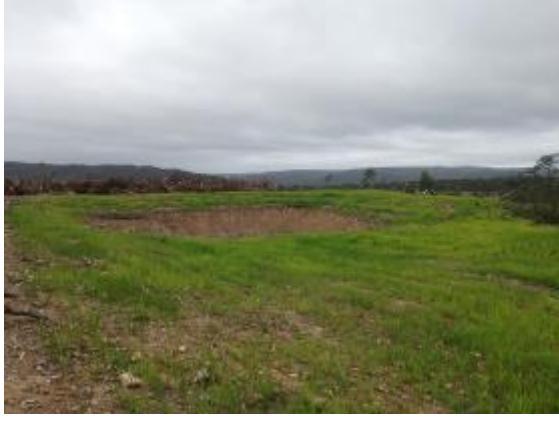
6-10. Rehabilitation Area – subject to maintenance

Evidence of progressive rehabilitation at a recently constructed dirty water channel was observed adjacent to the new reject emplacement area (REA).

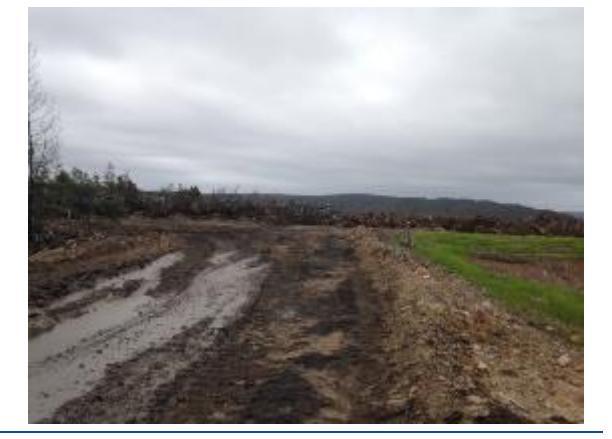
6-11. Rehabilitation Area – subject to maintenance

Stripped topsoil and trees from clearance of the new REA were observed.
